Premature bearing failures in industrial gearboxes

Kenred Stadler[°]

Arno Stubenrauch^{*}

SKF GmbH, Gunnar-Wester-Str. 12, 97421 Schweinfurt, Germany

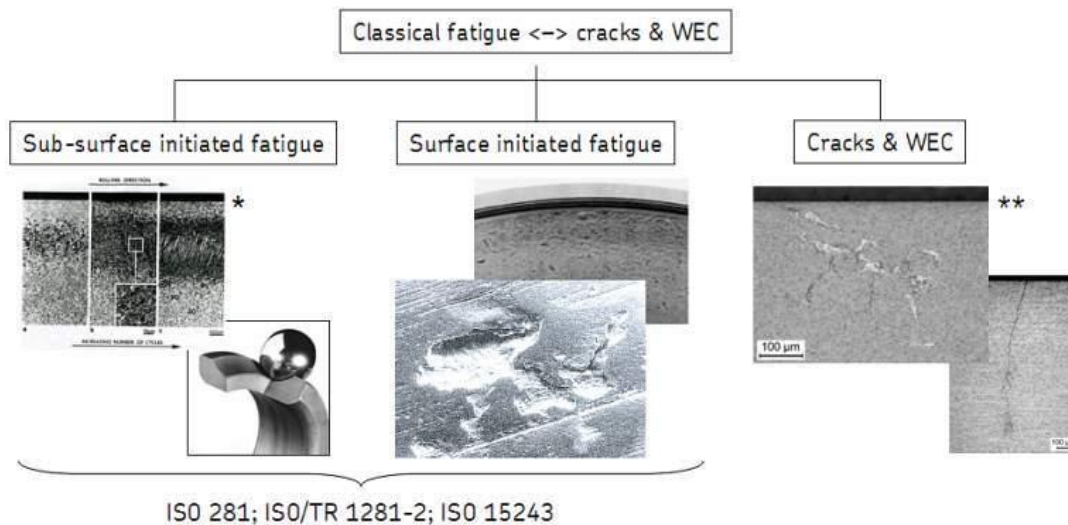
Many premature wind gearbox bearing damages are associated with a failure mode that is not caused by the classic rolling contact fatigue (RCF) mechanisms (figure 2). While these classic mechanisms are sub-surface initiated fatigue as well as surface initiated fatigue and can be predicted by standard bearing life calculation methods^{3, 4}, premature crack failures are not covered. Attempts to calculate bearing life have been made when detailed information of the case is available (e.g. local effect of hoop stresses)⁵. ISO 15243 describes the visual appearance of the classic rolling contact fatigue mechanisms.

Figure 2: Classic fatigue failure modes and WEC micrograph* according to Ref. 6, micrograph** according to Ref. 7

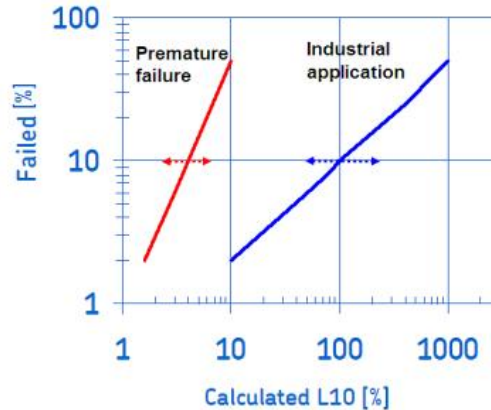
Figure 3: Typical for premature failures in industrial machinery is that – different to classic fatigue – bearings from identical machines in the same specific surroundings are failing within a consistent and short time period. The slope difference is a predictor of ‘other than classic fatigue’. Those having had short service life are likely to have short service life again if no further actions on the bearing-shaft-housing system are taken.

Known to occur only occasionally in some industrial applications such as paper mills, continuous variable drives, marine propulsion systems, crusher mill gearboxes or lifting gear drives, in wind applications the quantity of premature failures seems to be higher (but might be also related to a larger population). Early cracks have occurred commonly within the first 1-3 years of operational time or at 5-10% of the calculated rating life (see figure 3).

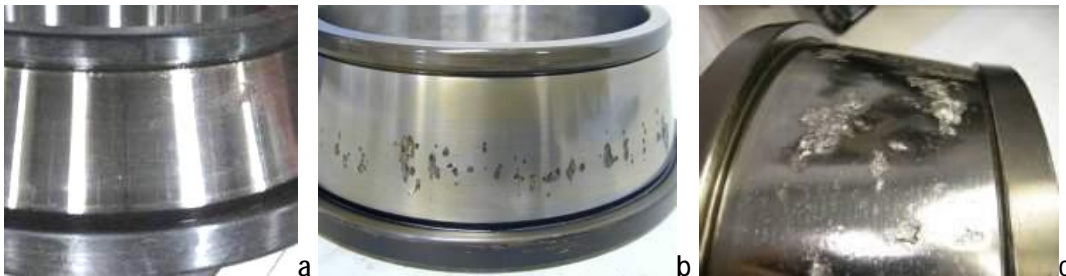
Figure 4: Failure appearance, a) straight cracks, b) straight cracks & small spalls, and c) spalls

Mostly occurring on the inner ring, as shown in figure 4, the visual appearance of early cracks varies from straight cracks (“axial cracks”), to cracks in combination with small spalls and large/heavy spalling. SKF’s field experience shows that early failures by cracks are neither linked to a particular type of bearing (figure 5) nor to a particular standard heat treatment (figure 6) ^{7, 8, 9, 10, 11}.

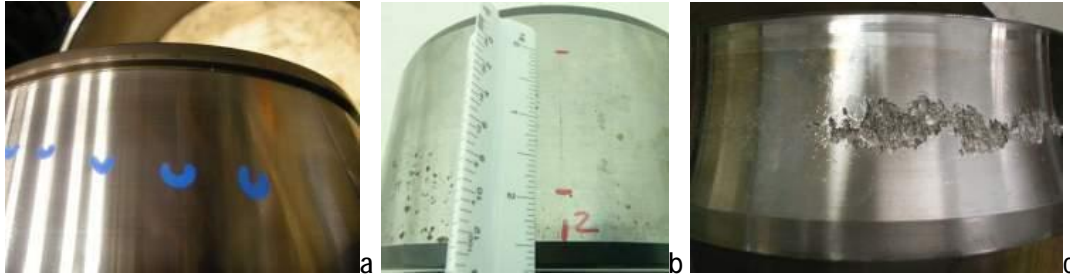
Figure 5: Examples of typical bearing types that can be affected, a) tapered roller bearing, b) cylindrical roller bearing, and c) spherical roller bearing

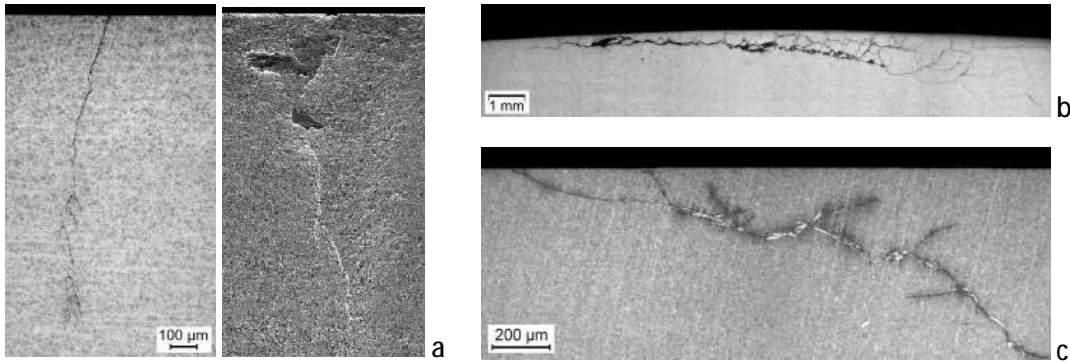
The failure appearance however is associated with the heat treatment (e.g. by the residual stress field), how far the failure has progressed and very likely also with the operating condition or bearing position (e.g. stress field from loading). As it can be seen in figure 6, for early cracking in this specific application, cracks in martensite rings tend to grow straight into the material (suggesting the straight “axial” crack appearance, e.g. figure 6a), whereas in bainitic (figure 6b) as well as in carburized case hardened rings, the cracks tend to grow circumferentially below the raceway (explaining the spall/flaking type of appearance, e.g. figure 6c). Nevertheless, in a very advanced failure stage, the inner ring raceways are often heavily spalled, independent of the heat treatment.

Figure 6: Crack growth patterns in standard heat treatments, a) martensite, b) bainitic, and c) case hardened (case carburized)⁷

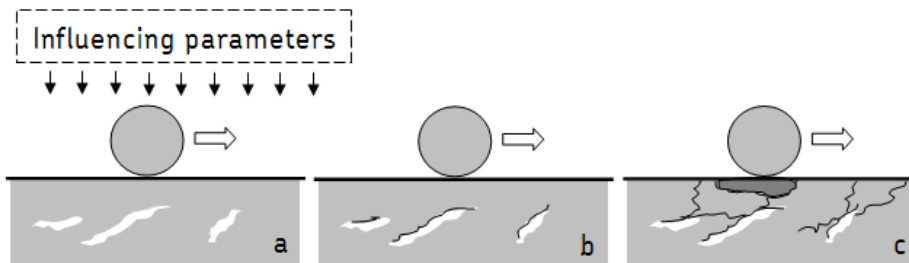
Nevertheless, many of the existing theories from literature can be briefly summarized as tried in figure 7. A lot of papers (e.g., reference 10, 11) discuss a local change in the bearing material microstructure as precursor of WEC caused by certain influencing factors.

Figure 7: According to many existing theories in literature: a) certain influencing factors change locally the microstructure into white etching areas (WEA), b) WEA are starting points of cracks (WEC), and finally c) white structure flaking (WSF) due to crack propagation, reaching the bearing raceway

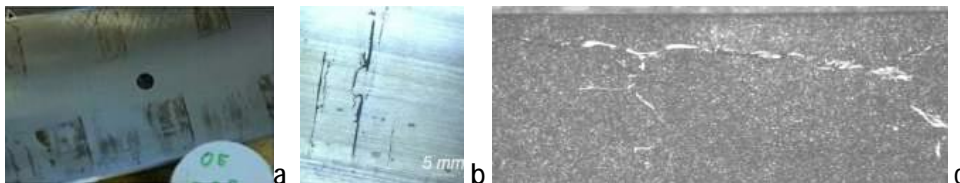
b) The presence of free water leads likewise to a high corrosive environment³⁵ (see figure 9), but elevated water contents in the lubricants are claimed to be under control by the turbine manufacturers. Moisture corrosion in wind gearboxes is usually not seen during SKF investigations.

Figure 9: SKF standstill corrosion test with elevated water content; a) standstill corrosion marks, b) crack on ring due to continuing running, c) microsection of one of these rings

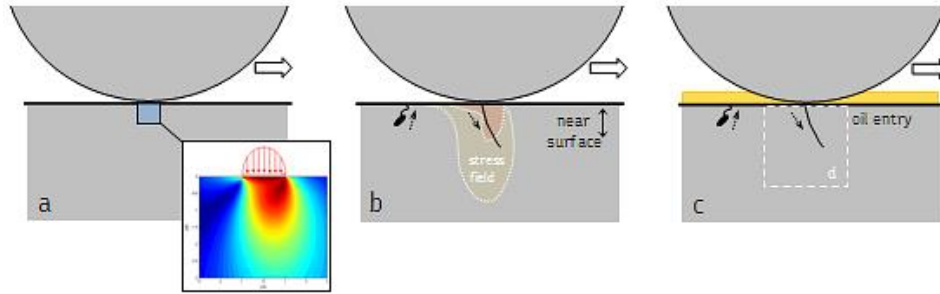
As schematically shown in figure 11, transient conditions can trigger cracks in the surface region, possibly accelerated by tribochemical effects^{7, 17, 39, 41, 42}, or sub-surface cracks that reach the raceway when starting at weak points such as inclusions close to the surface⁷.

Figure 11: a) roller-raceway contact with areas of local high traction, e.g. due to local mixed friction, leading to tensile stresses that can b) lead to a damage like a small crack; c) a surface crack or crack connected to the raceways allows the entry of oil; for area d), see figure 15 for more details

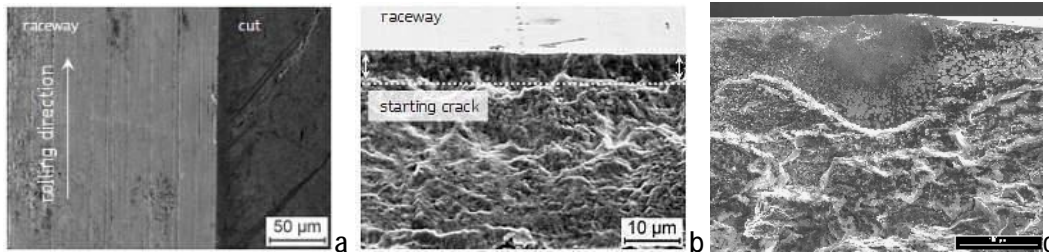
The inclusions can be soft MnS or hard oxides that naturally exist in any bearing steel. In addition, small MnS lines at the raceway can sometimes be dissolved by the lubricant and act also as potential surface cracks^{7, 17} and/or environmental corrosive cracks. Examples of a shallow surface crack are shown in figure 12 and 13, and often it requires significant effort and experience to find them at an early stage^{7, 8, 17}.

Figure 12: a) small shallow crack at the raceway and further crack propagation, smoothed machining marks indicate potential mixed friction conditions, b) opening of a shallow surface crack, c) surface crack triggered by near-surface inclusion (scanning electron microscope fractographs)

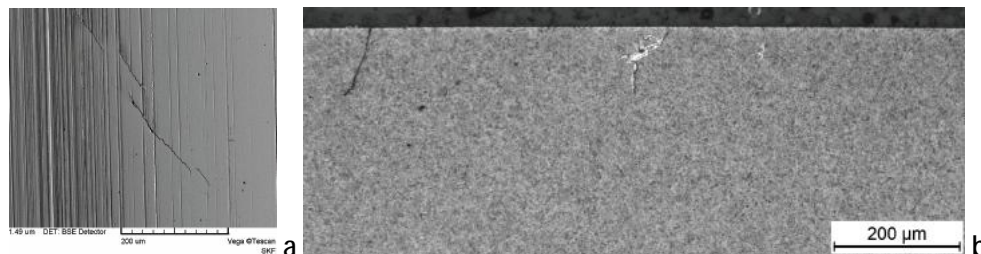
Figure 13: Cracks on rolling-sliding components from an automotive application, a) small friction induced cracks on the raceway - smoothed machining marks indicate mixed friction conditions, b) circumferential microsection showing a non-decorated crack (left) and white etching decorated crack (right)

The cracks shown in figures 13 & 14 are generated in an automotive rolling-sliding contact at high traction and contact pressures, similar to potential critical wind load situations (short term events) of around 3 GPa¹⁹.

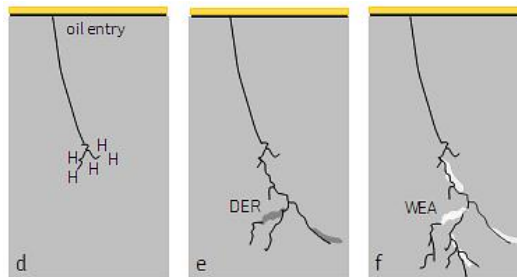
Once the bearing raceway is locally damaged, the highly EP/AW doped lubricant will penetrate into the crack. Depending on the crack orientation, hydraulic effects will additionally push the crack propagation⁴⁷. As indicated in figure 15, the lubricant (often aged and/or contaminated with water) will react inside the material at the fresh metallic crack flanks. In other words, a corrosion fatigue crack propagation process, CFC, is triggered.

Figure 15: d) after penetration, oil and additives react in the crack flanks locally producing hydrogen, e) and f) the hydrogen transforms locally the microstructure close to the crack system into White Etching Cracks WEC (from dark etching regions, DER, to white etching areas, WEA)^{7, 8, 17}

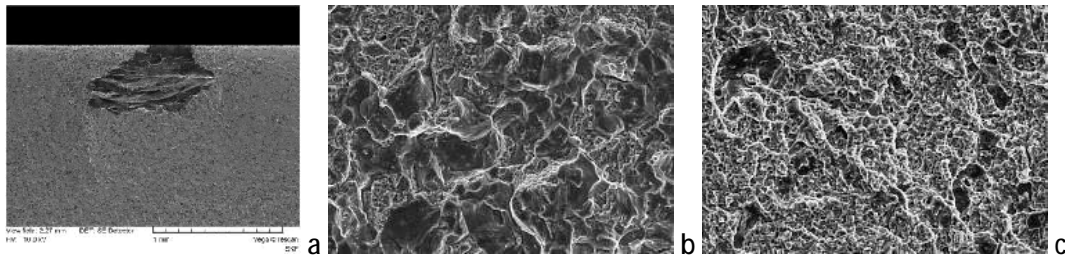
As shown in figure 16, a fractographic investigation in the preparative opened forced fracture face close to the inner ring crack reveals an intercrystalline microstructure

that indicates material embrittlement by hydrogen, released from the aging lubricant products^{7, 8, 17, 42}, whereas distant from the CFC crack, a normal largely transcrystalline fracture face is seen. Further indication of such a CFC mechanism is found by EDX analysis of lubricant and additive residuals within the opened crack system^{7, 8, 17}.

Figure 16: a) axial opening of a crack connected to the surface, b) intercrystalline microstructure close to the crack system, c) transcrystalline microstructure elsewhere

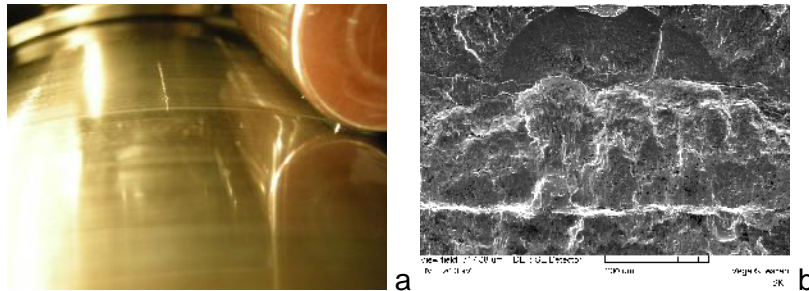
Figure 18: SKF wind bearing test; a) crack on inner ring, b) axial opening of a crack connected to the surface (compare with figure 12c and 16a)
